Manhole Inspection Summary

Manhole # S51K__050MH

Insp Date: **3/31/08 12:32 PM**

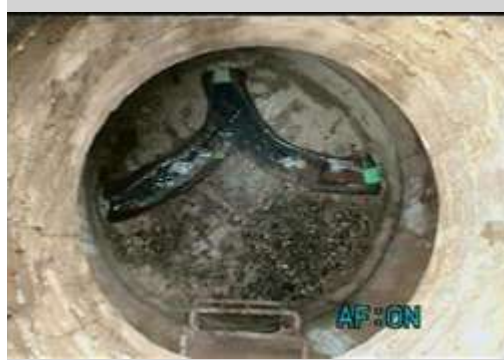
Top View

bench debris

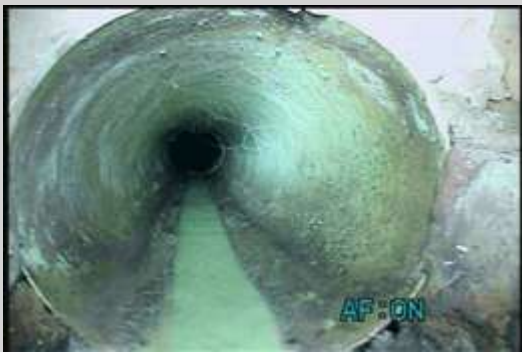
12 O'Clock Outflow

8 in. Circular Gravity Sewer
Pipe Out @ 12 O'Clock

Pipe Height: 0 (in.) Direct

Pipe Material: PVC ☐ Pipe Lined

Invert Depth: 7.58 (ft.) Flow Characteristics: Fast

Deposits: ☒ None ☐ Mud ☐ Sludge ☐ Debris ☐ Grease

Infiltration: None Pipe Seal Cond: Unknown

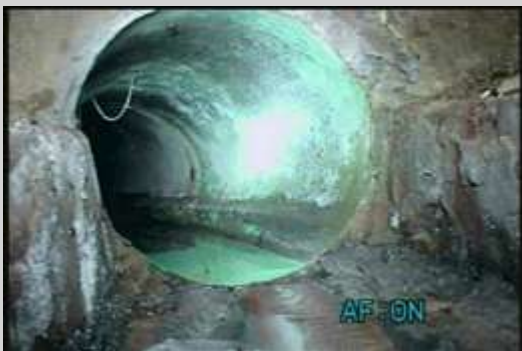
3 O'Clock Inflow

8 in. Circular Gravity Sewer
Pipe In @ 3 O'Clock

Pipe Height: 0 (in.) Direct

Pipe Material: PVC ☐ Pipe Lined

Invert Depth: 7.58 (ft.) Flow Characteristics: Fast

Deposits: ☒ None ☐ Mud ☐ Sludge ☐ Debris ☐ Grease

Infiltration: None Pipe Seal Cond: Unknown

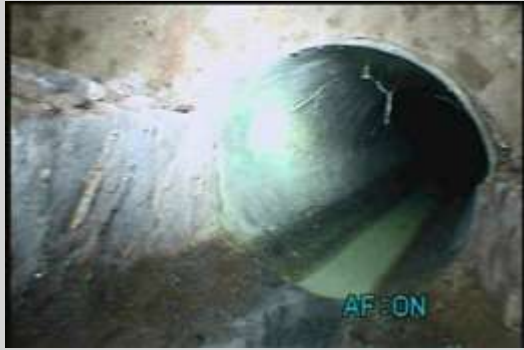
9 O'Clock Inflow

8 in. Circular Gravity Sewer

Pipe In @ 9 O'Clock

Pipe Height: **0** (in.) Direct

Pipe Material: **PVC** ☐ Pipe Lined

Infiltration: **None** Pipe Seal Cond: **Unknown**
